NATIONAL TRANSPORTATION SAFETY BOARD

AIRCRAFT ACCIDENT REPORT

**AIR WISCONSIN, INC.,
SWEARINGEN SA-226 METRO, N650S
VALLEY, NEBRASKA
JUNE 12, 1980**

NTSB-AAR-80-15

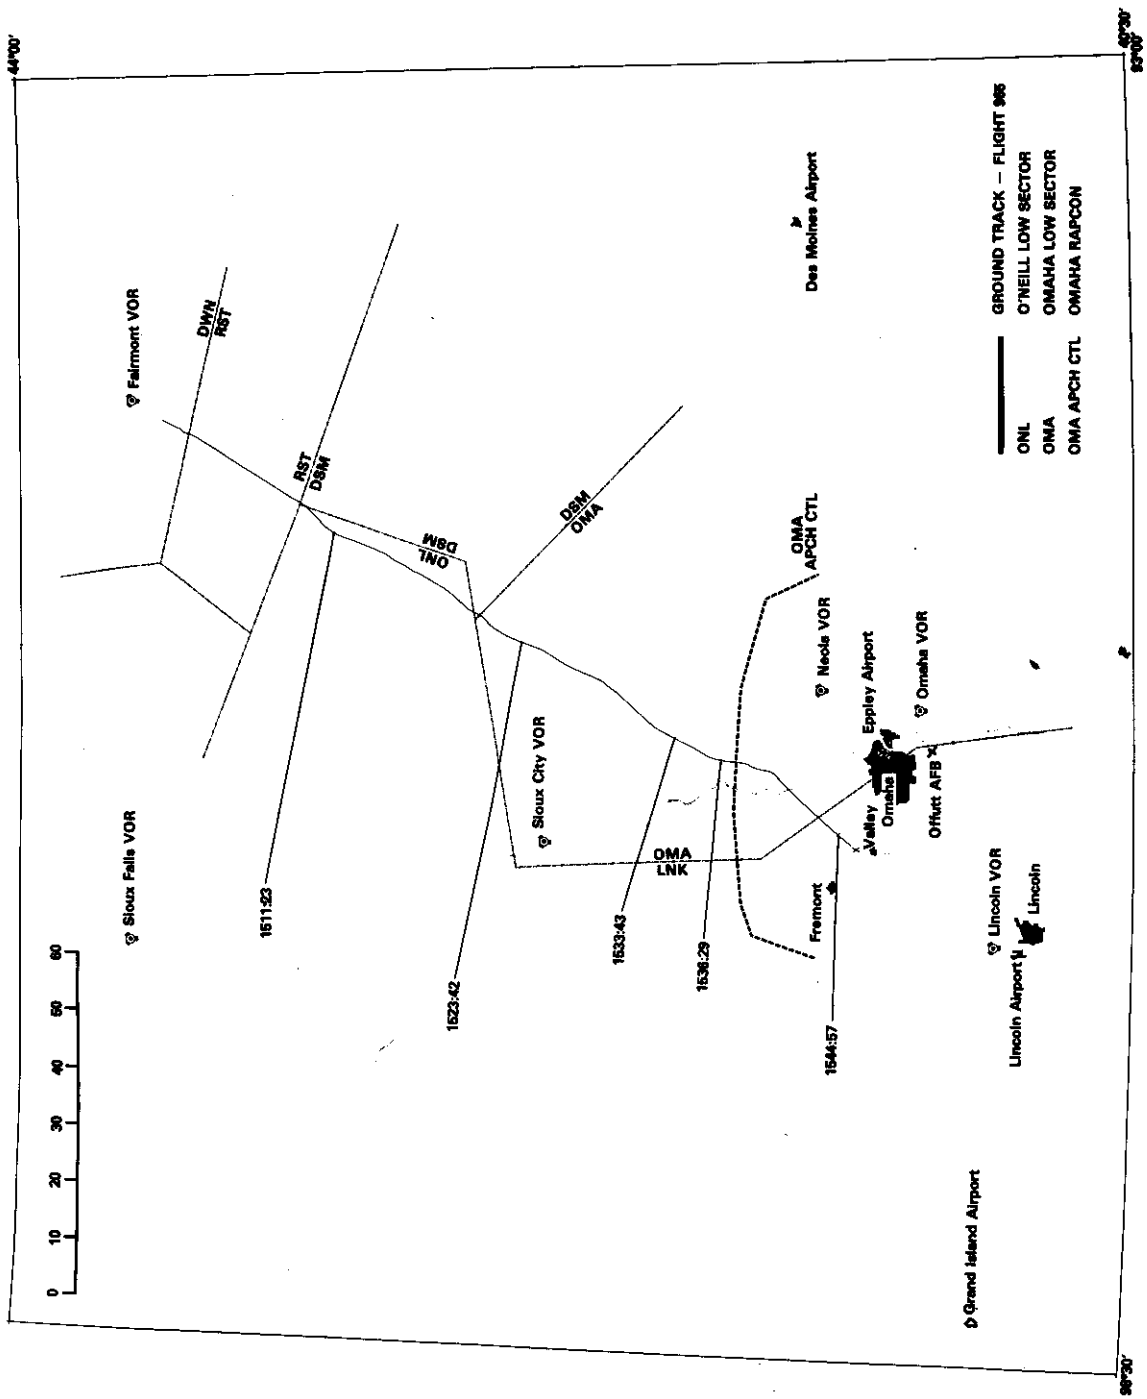
Figure 1.--Probable Ground Track

At 1511:23, the Minneapolis ARTCC O'Neill low controller said, "Wisconsin 965, there's a large area of weather twelve o'clock and about thirty five miles and extends from east of Neola up around Sioux City and down the west side to Fremont. Had one aircraft at flight level two zero zero went around the area. Another one at nine thousand inbound to Lincoln, found his way through it. Don't know how bad it is, anything else. He said he could pick his way through pretty good, though." (See figure 1.)

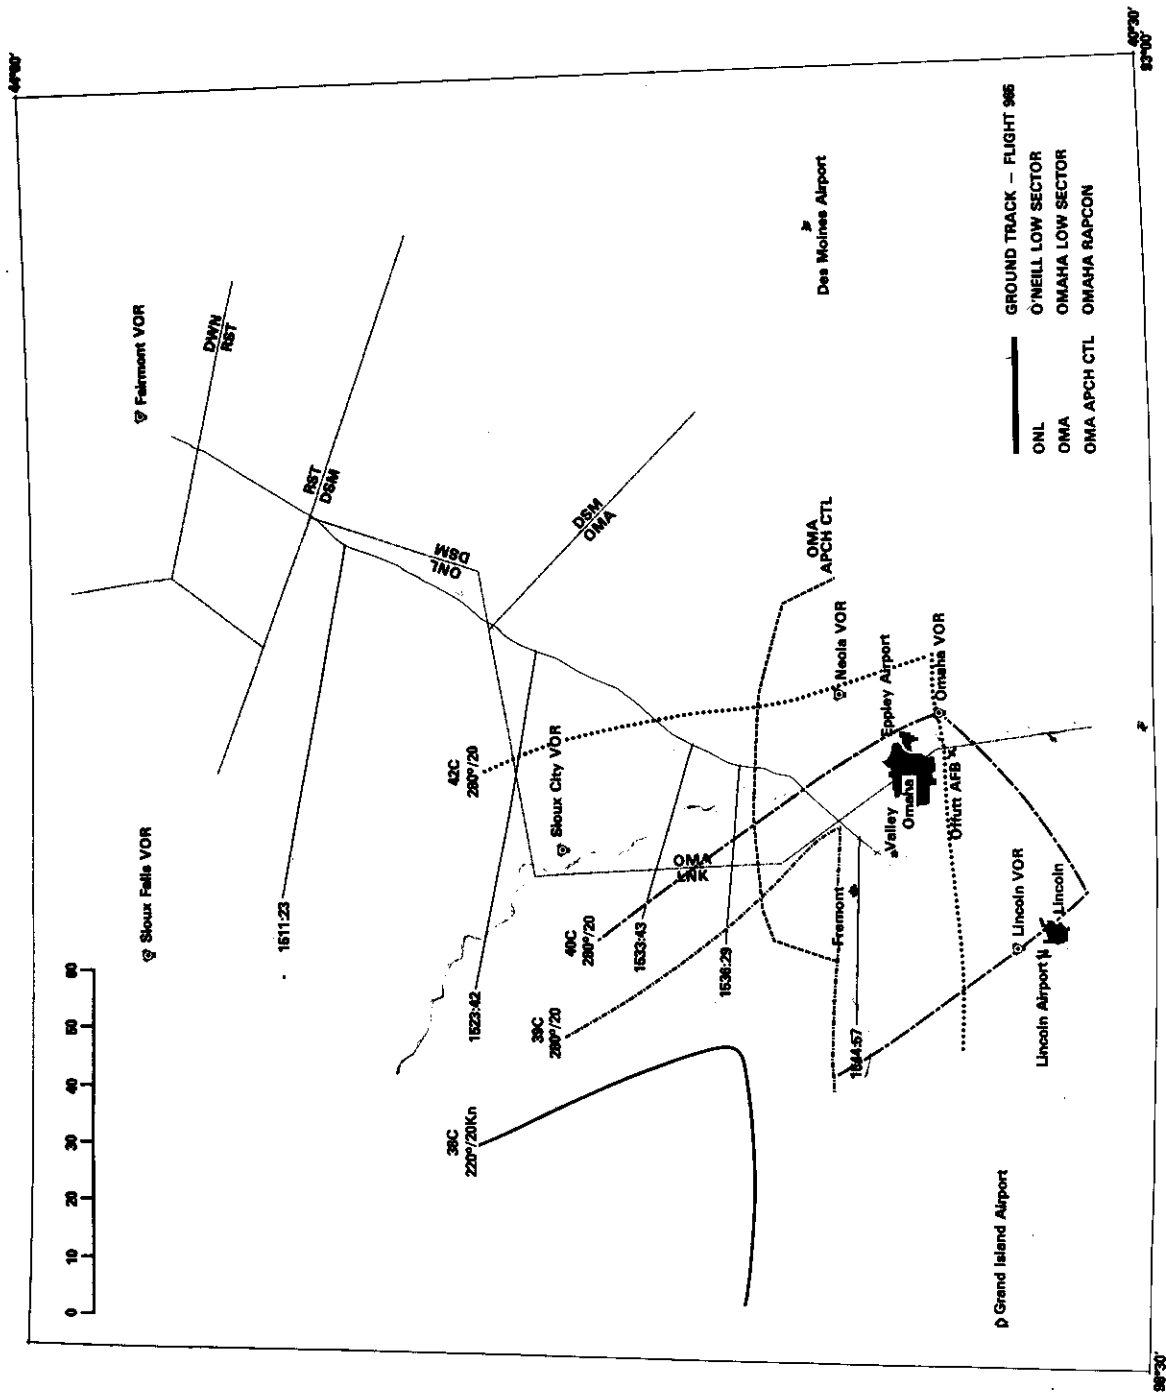
Figure 2.-- Location of convective SIGMET's.

*Convective SIGMET 42C, issued at 1455, stated:

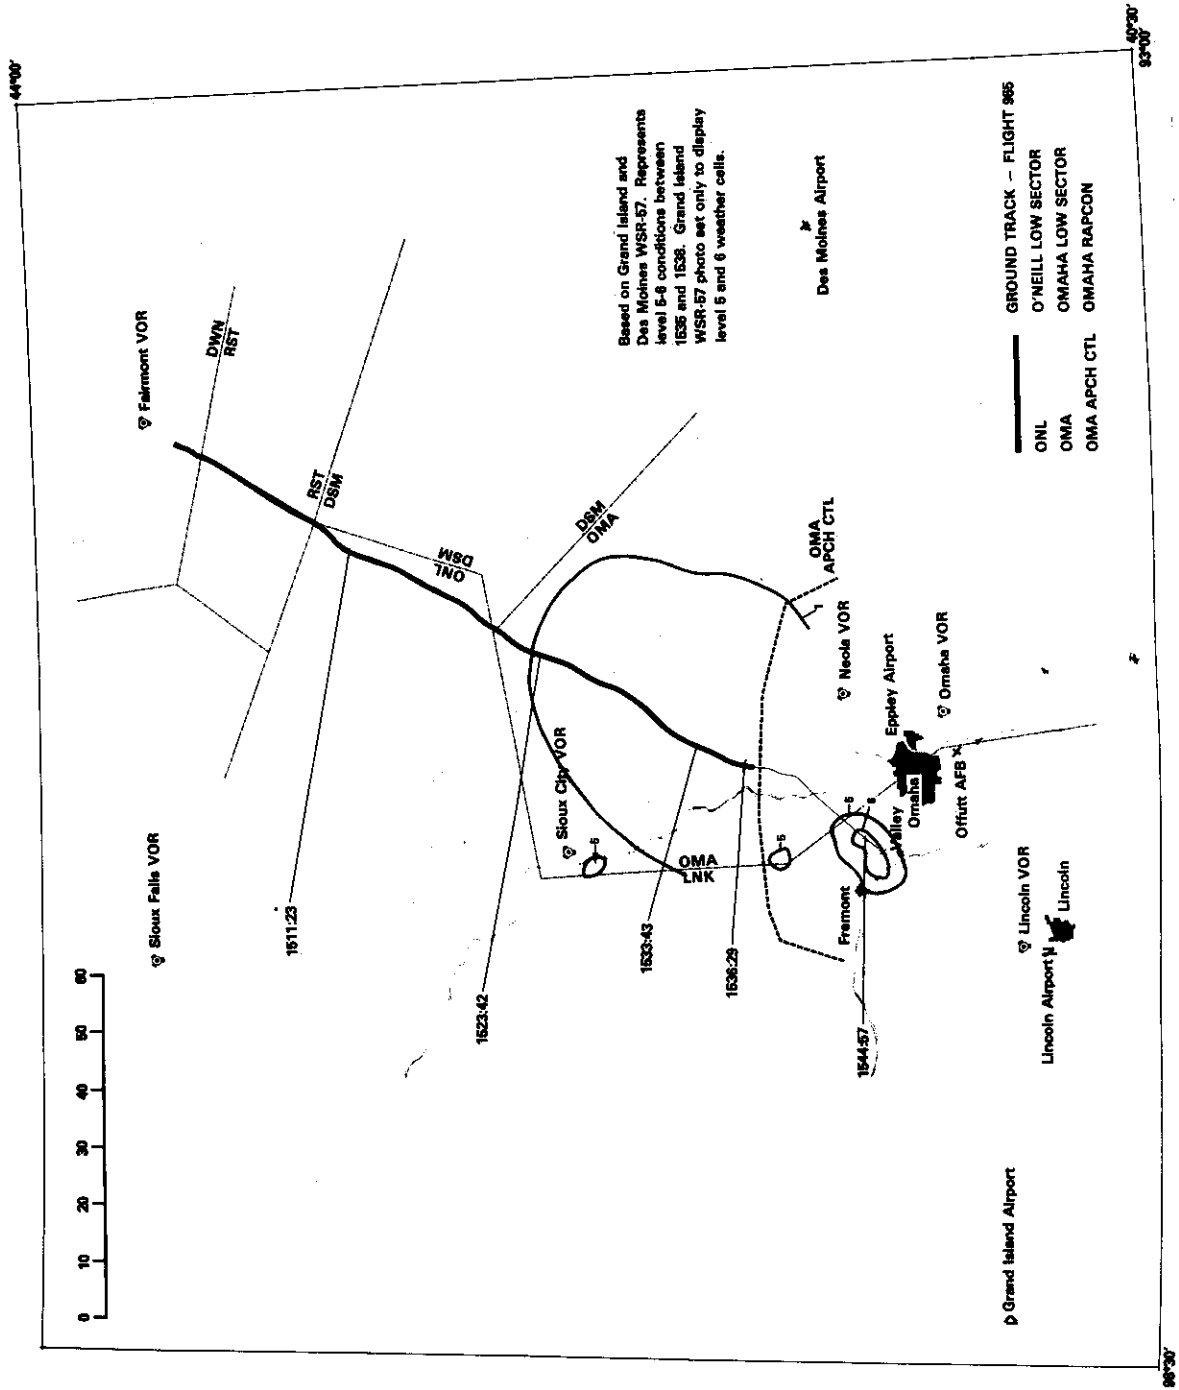
Figure 4.--Weather Echos-Flight Track Overlay

observed VIP level 5 thunderstorms on the WSR-74C radarscope in the Omaha office between 1500 and 1550. The weather radar overlay prepared at Omaha at 1545 showed two VIP level 5 weather echo cores. One was located about 7 miles north-northeast of Valley and the other about 10 miles northeast of Valley. The lead forecaster observed that when the storm entered northwest Douglas County "it built rapidly southwestward."

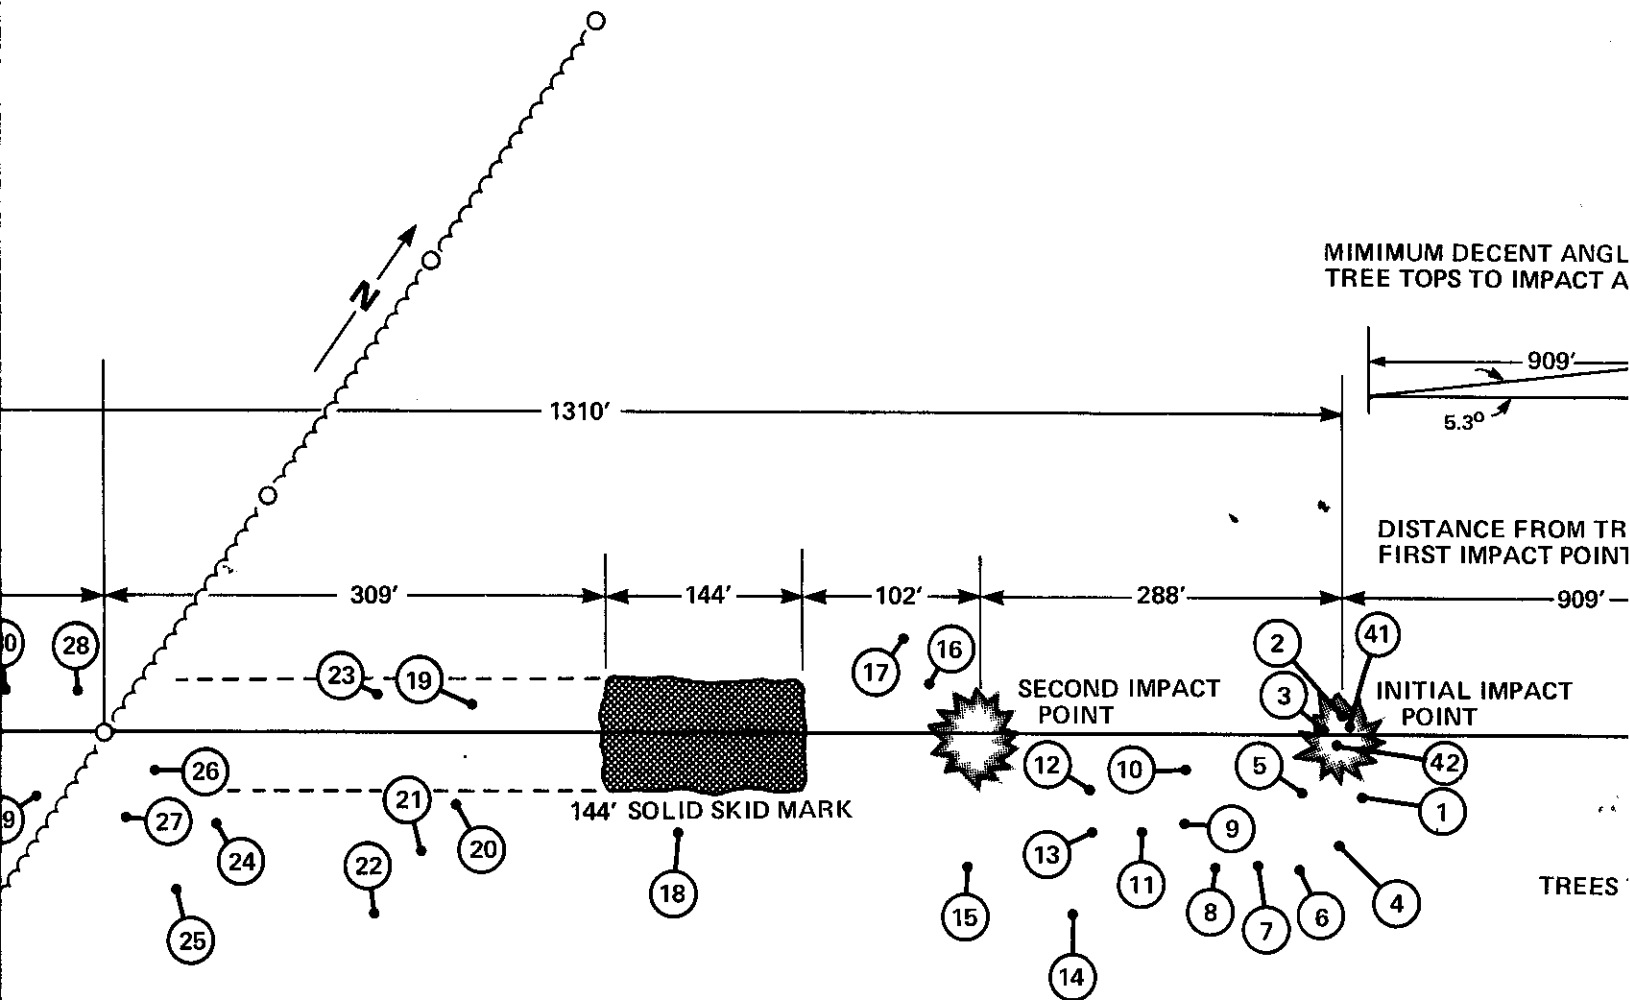
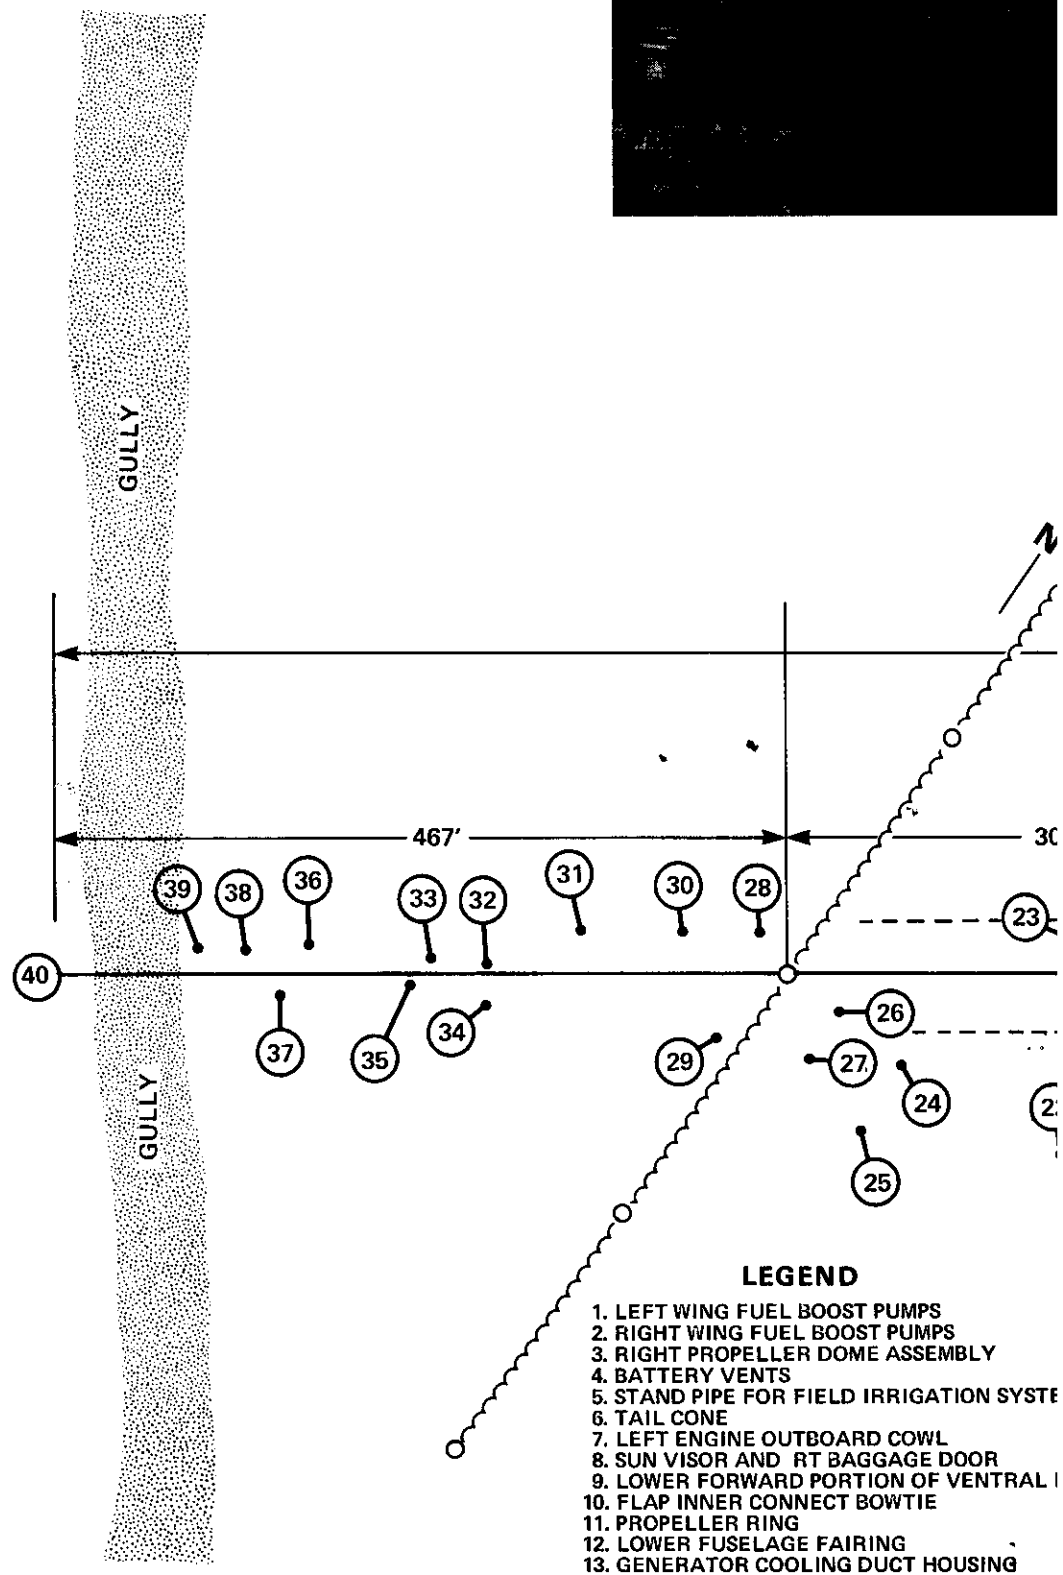
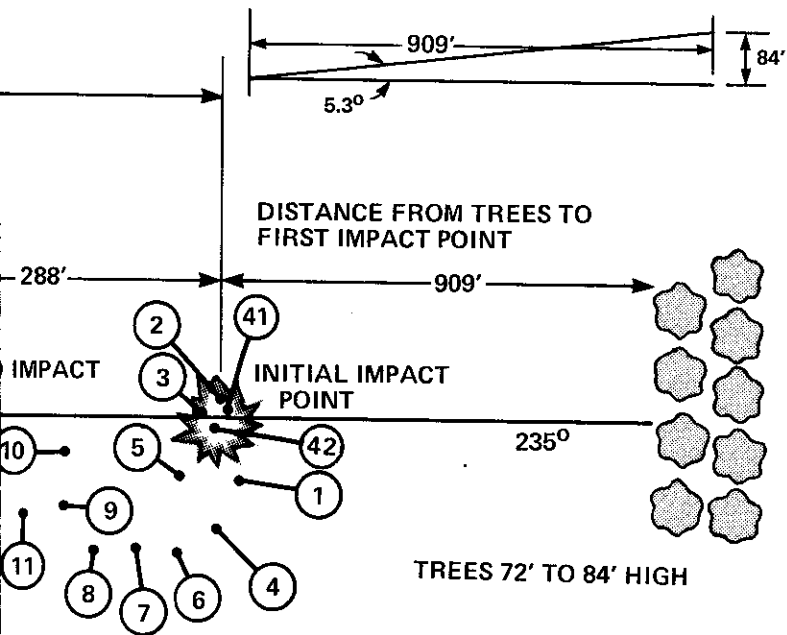
Wreckage Distribution Chart
 Air Wisconsin Swearingen
 Model SA-226TC, N650S

The empennage separated from the fuselage about 665 ft beyond the initial point of impact, and both engines and wings were found between 900 ft and 1,150 ft from the initial impact point. The propeller assemblies had separated from the powerplants, which had separated from the wings. (See appendix D.)

MINIMUM DECENT ANGLE FROM
TREE TOPS TO IMPACT AREA = 5.3°
